NASA Contractor Report 159071

Flight Service Evaluation of Kevlar-49, Epoxy Composite Panels in Wide-Bodied Commercial Transport Aircraft

Fifth Annual Flight Service Report

**Contract NAS 1-11621
March 1979**

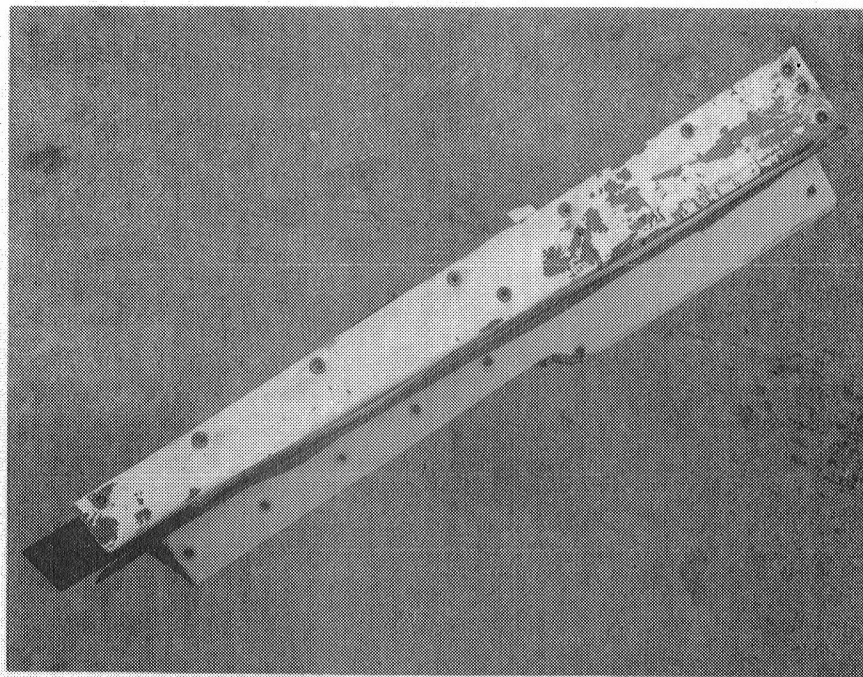
1. The panel weight was 0.9 kg (2.1 lb). The previous weight, recorded in 1977, was 1.0 kg (2.2 lb).
2. The Kevlar-49 exterior surface still had considerable paint loss with some bare Kevlar-49 surface exposed (figure 2). No apparent effects or damage are associated with these areas. This part is not exposed to sunlight, so there should be no ultraviolet effects on the bare Kevlar-49 surface.
3. Fraying of fastener holes was visible particularly on the inner edge, and more pronounced on the lower edge (figure 8). No increased degree of fraying was observed over that noted in 1977.
4. The same elongated holes were observed as in the 1975 and 1977 inspections with no increase in degree of elongation. These include three severely elongated holes.
5. A slight gouge on the upper forward area of the inner surface, observed in 1977, had not changed in appearance.

Figure 2. - Eastern left-hand underwing fillet - exterior.

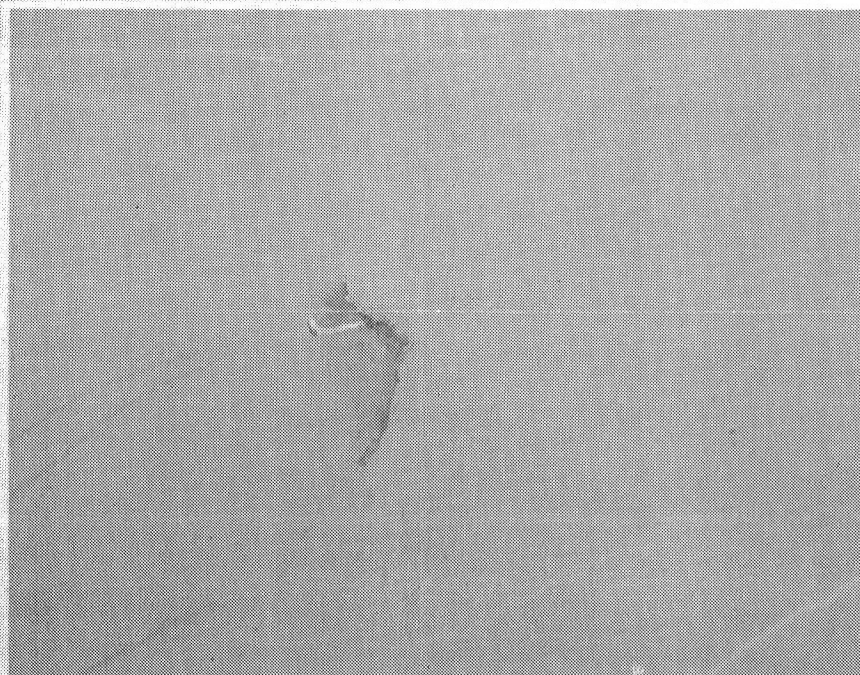
1. The panel weight was 6.9 kg (15.2 lb). The original recorded panel weight was 7.0 kg (15.5 lb).
2. A deep gouge and associated crack was noted in the upper forward area of the exterior surface (figure 4). The maximum depth was 0.06 cm (1/16 in.), and the honeycomb was exposed. The length of this crack was approximately 2.5 cm (1 inch) across the chord from end to end of the crack. There was no associated delamination except immediately adjacent to the crack. This was definitely caused by impact, probably from ground handling.

Figure 4. - Eastern left-hand wing-body fairing - deep gouge and crack with exposed honeycomb, 2.5 cm (1 in.) length.

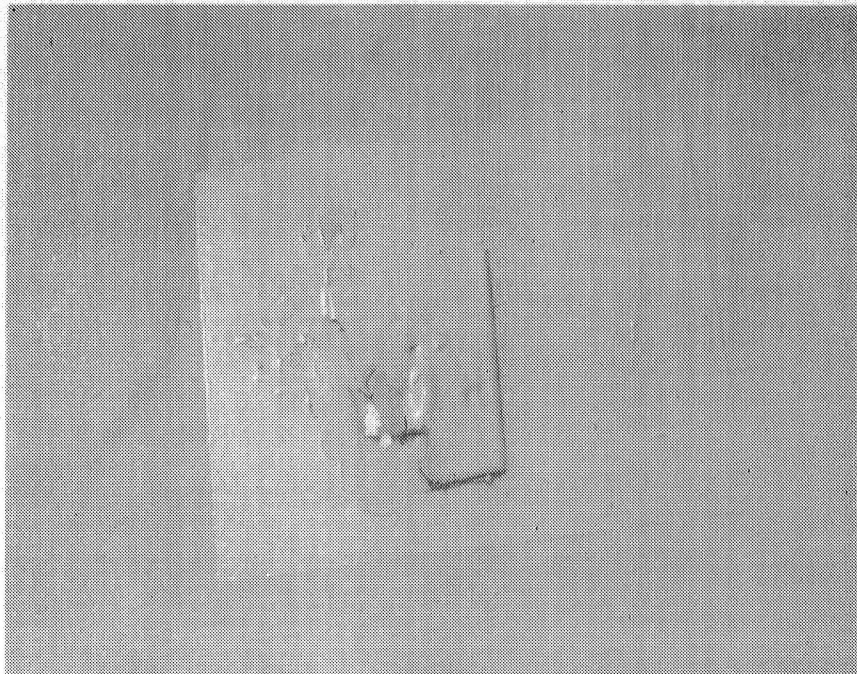
3. A speed tape patch first noted in 1975 remains unchanged in appearance (figure 5) since the last inspection. This patch is approximately 3.2 cm by 4.5 cm (1 1/4 by 1 3/4 inch) in area.

Figure 5. - Eastern left-hand wing-body fairing - speed tape patch, 3.2 by 4.5 cm (1 1/4 by 1 3/4 in.).

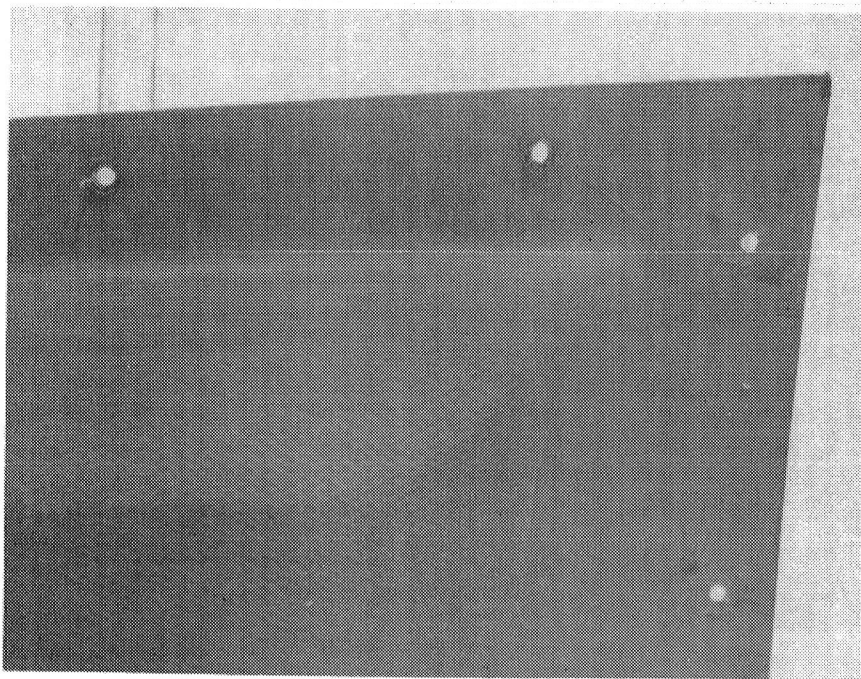
5. Slight fraying was observed on most fastener holes particularly along the bottom edge (figure 6). The condition is observed primarily on the inner surface, but is also visible from the exterior surface.

Figure 6. - Eastern left-hand wing-body fairing - typical frayed fastener holes.

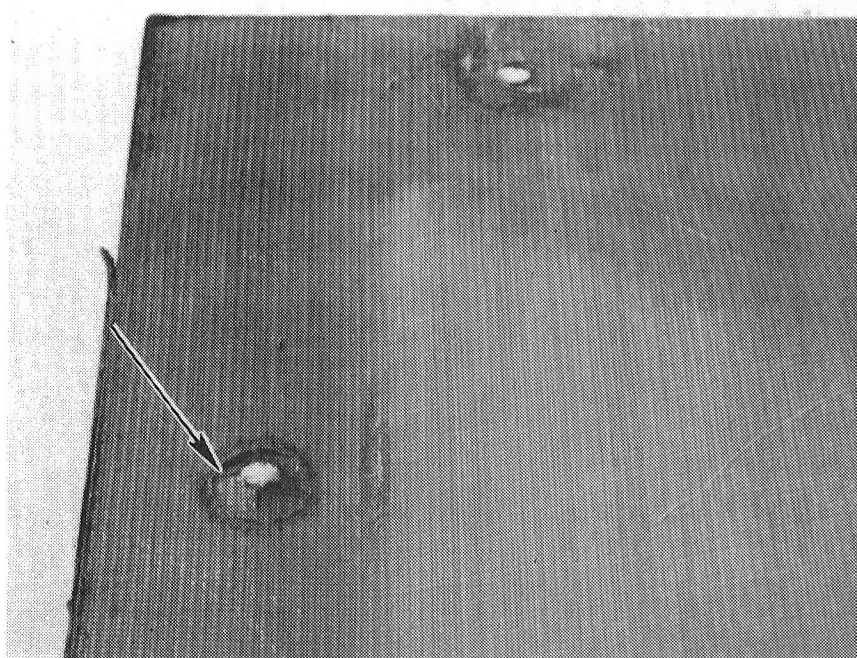
Figure 7. - Eastern left-hand wing-body fairing - elongated hole with convex deformation on lower edge.

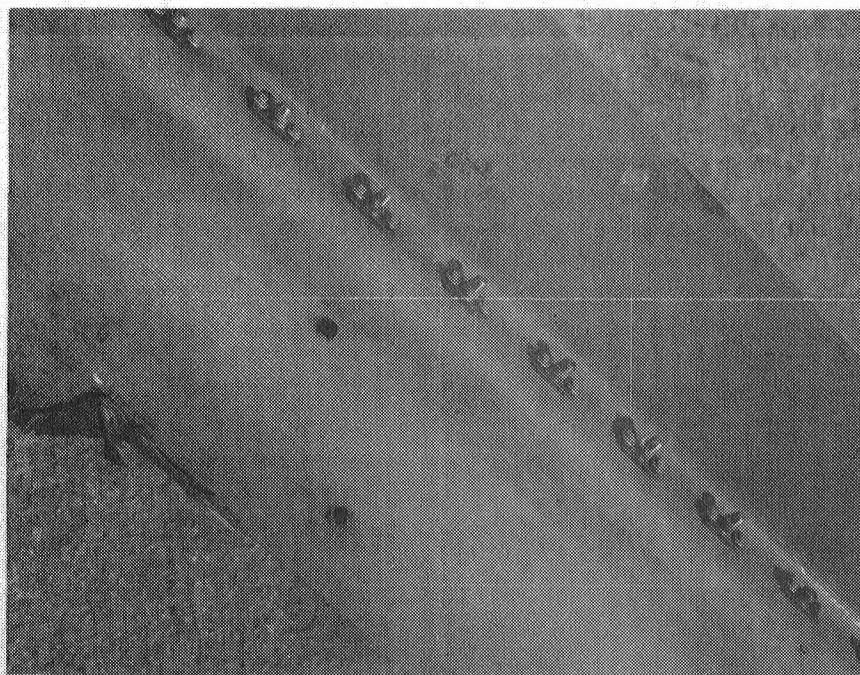
Figure 8. - Eastern left-hand underwing fillet - frayed fastener holes.

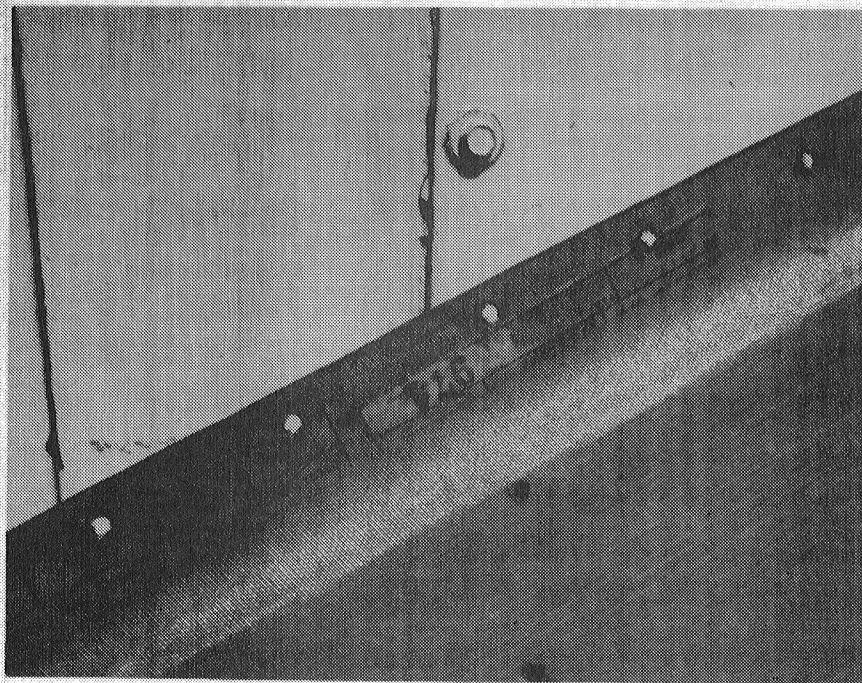
1. The panel weight was 3.3 kg (7.2 lb). No previous weight had been recorded.
2. Fraying was observed on all fastener holes, and was more evident viewed from the inner surface. The fraying was particularly severe on the lower aft edge. The upper aft edge, and a majority of the holes on the upper and lower edges were also severely frayed. Intercostal holes were less frayed, for the most part, but a few slightly elongated holes were observed (figure 9).
3. No surface damage or defects were noted on either the external or inner surfaces.

Figure 9. - Eastern left-hand aft engine fairing - frayed and elongated fastener holes.

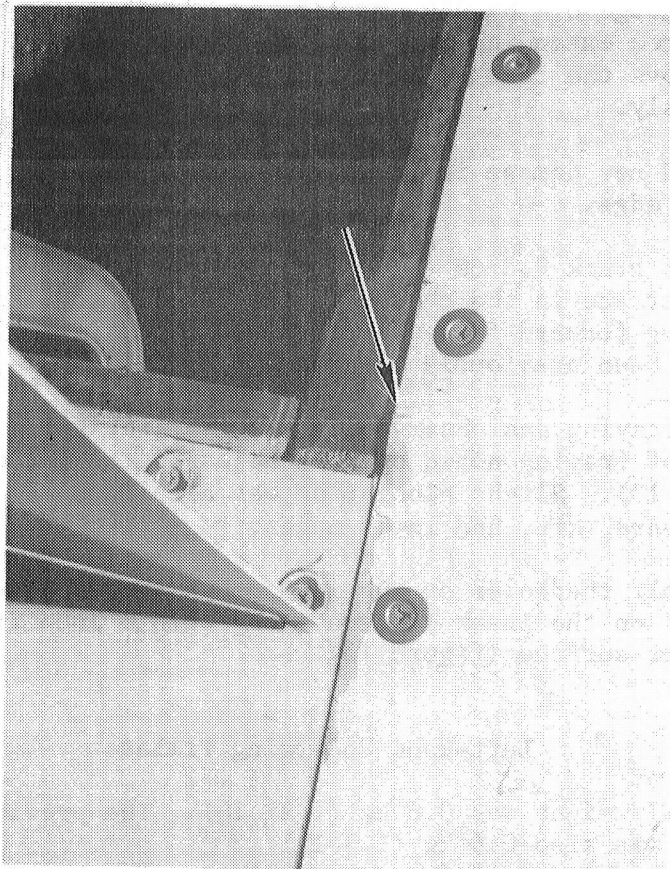
1. Several surface cracks observed in previous inspection were unchanged in appearance or extent:
 - A 1.3 cm (1/2 in.) crack between the fifth and sixth holes from the top along the forward edge (figure 10)
 - A 0.3 cm (1/8 in.) ding in the lower center area
 - A 0.3 cm (1/8 in.) crack in the aft center area

Figure 10. - Eastern right-hand wing-body fairing - crack on forward edge 1.3 cm (1/2 in.) length.

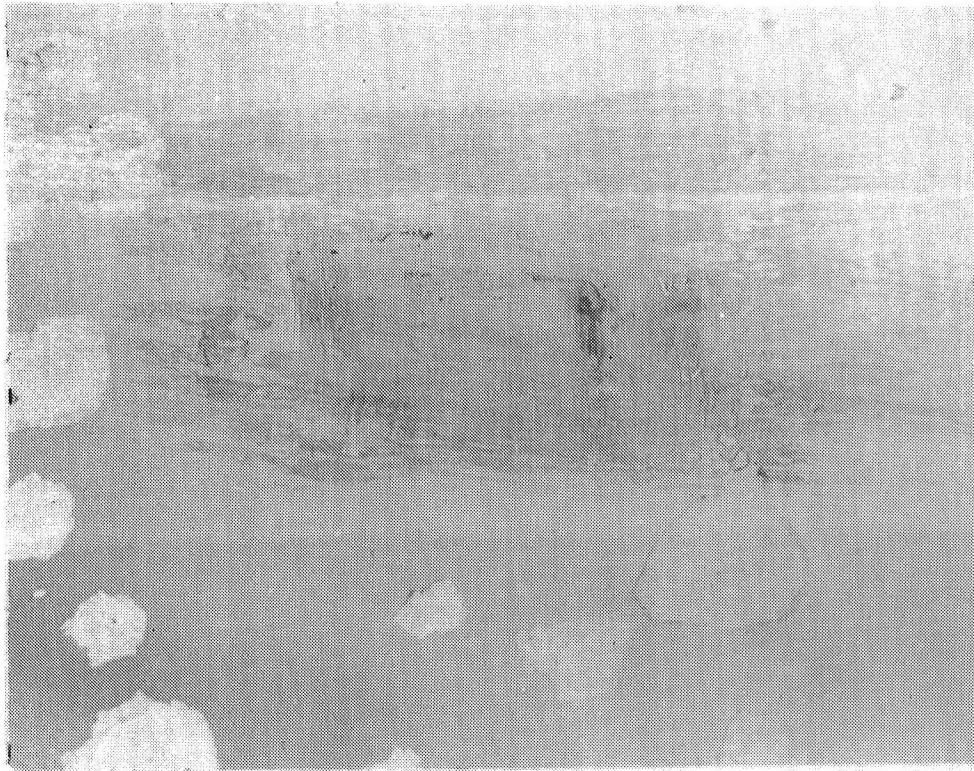
1. The panel weight was 6.9 kg (15 1/4 lb). The previous recorded panel weight in 1977 was 7.0 kg (15 3/8 lb).
2. A surface crack 3.2 cm (1 1/4 in.) long in the upper aft area, first observed in 1974 and then in subsequent inspections, had been repaired since the 1977 inspection. The crack had been filled in with resin and coated with conductive paint (figure 11). There was no record of this maintenance action.

Figure 11. - Air Canada left-hand wing-body fairing - repair area on exterior.

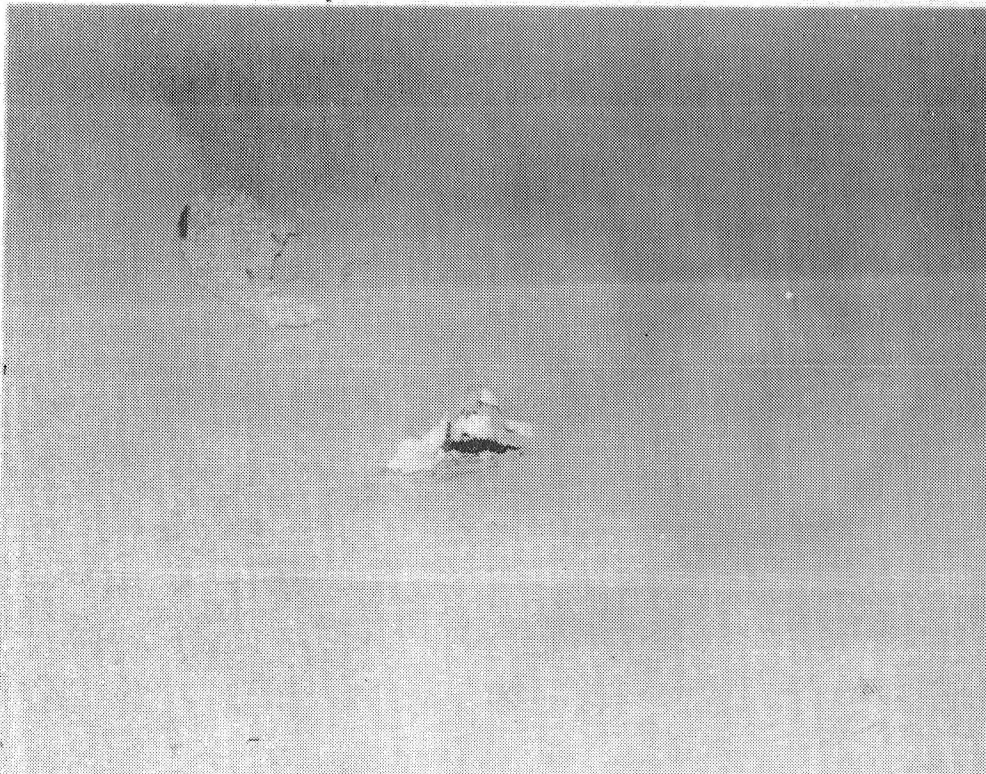
3. A deep gouge 0.4 by 0.6 cm (5/32 by 1/4 in.) was noted in the upper area extending into the core, with a slight delaminated area above the crack (figure 12). This had not been observed previously.

Figure 12. - Air Canada left-hand wing-body fairing - deep gouge with exposed core 0.4 cm by 0.6 cm (5/32 by 1/4 in.).

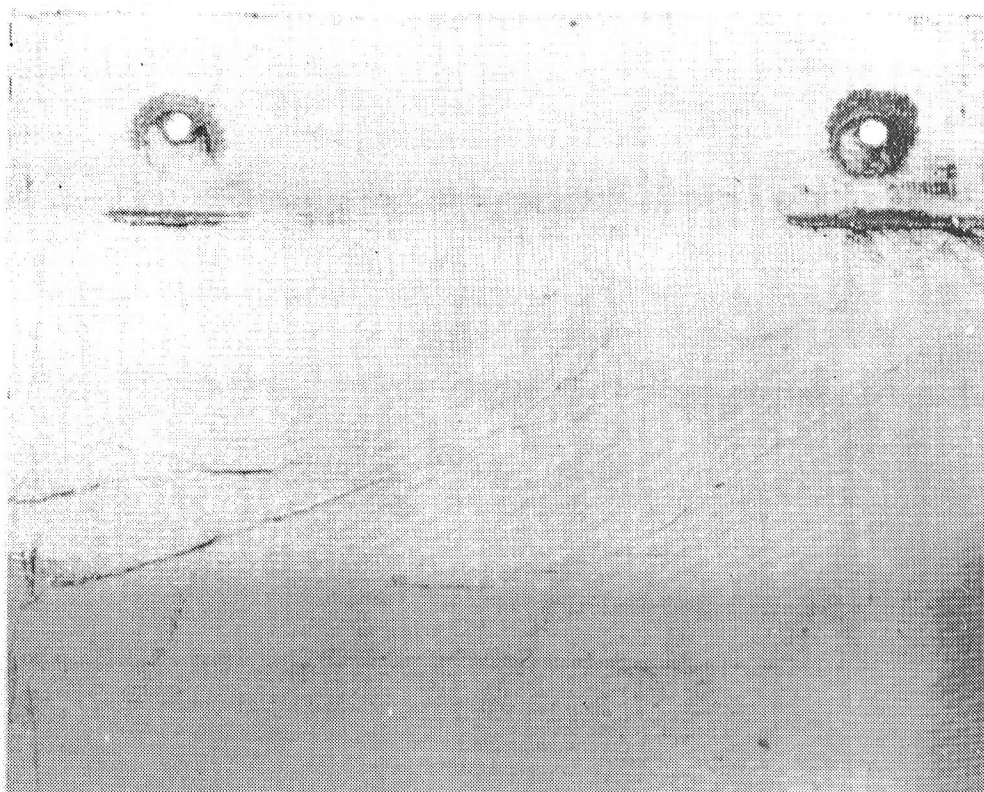
6. Slight fraying was observed on all fastener holes, with the greatest degree of fraying noted on some holes on the aft and lower edges (figure 13). Slight elongation was also noted on several holes on the forward, aft, and lower edges.

Figure 13. - Air Canada left-hand wing-body fairing - frayed fastener holes on lower edge, with deformation and mark-off of laminate around holes.

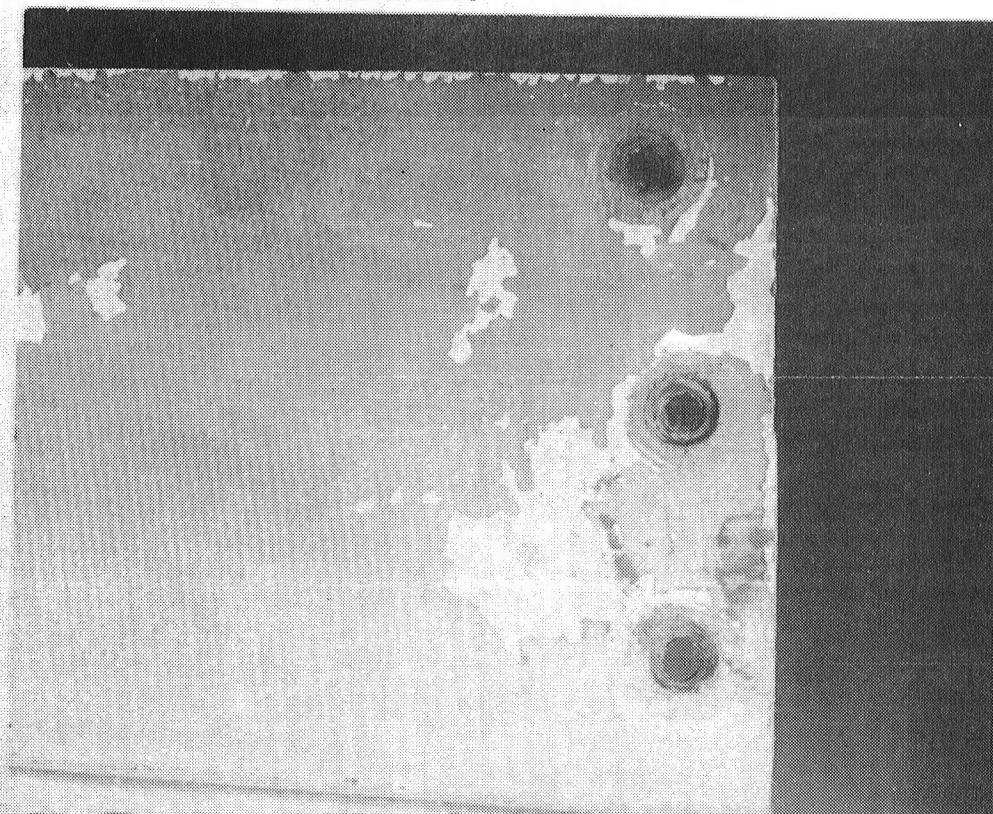
2. The exterior surface had extensive paint loss with the Kevlar-49 surface exposed in the upper area. No damage to the laminate was observed on either surface.
3. Slight fraying was observed in most of the fastener holes (figure 14). Elongation was also observed in most of these holes. Eight of the elongated holes had a significant degree of deformation with elongations to 0.6 cm (1/4 in.) and in one case 0.7 cm (9/32 in.) from the original 0.5 cm (3/16 in.) size (figure 15). These holes had a random distribution on the fairing.

Figure 14. - Air Canada left-hand underwing fillet - typical frayed fastener holes.

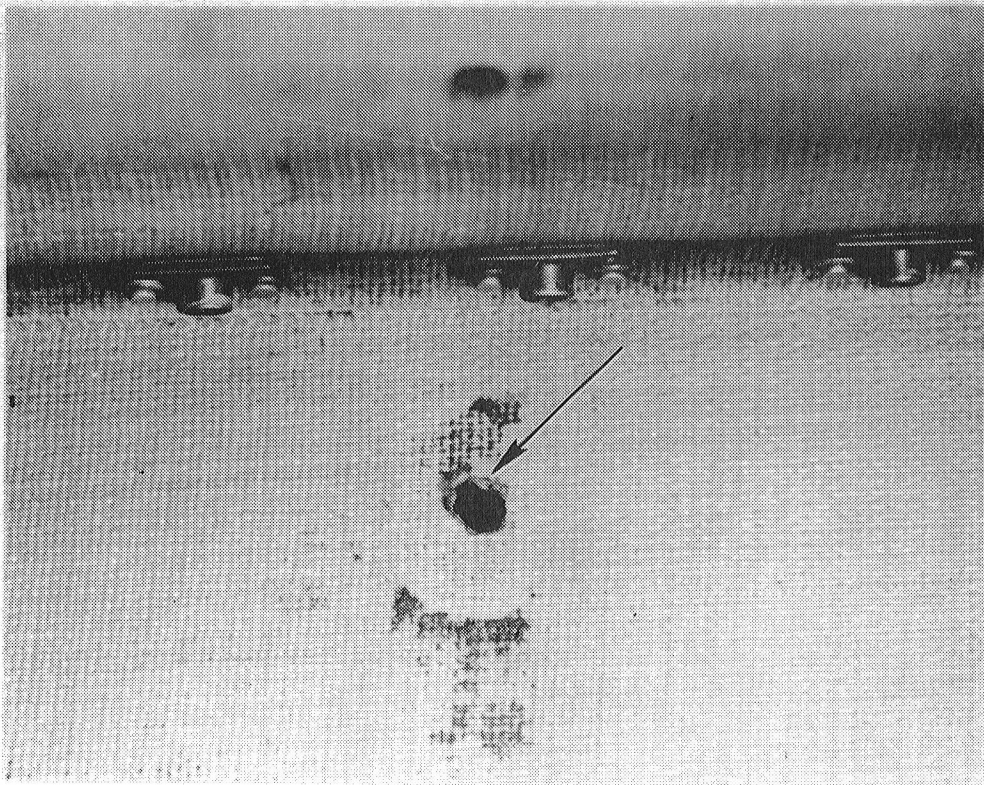
Figure 15. - Air Canada left-hand underwing fillet - badly elongated fastener hole.

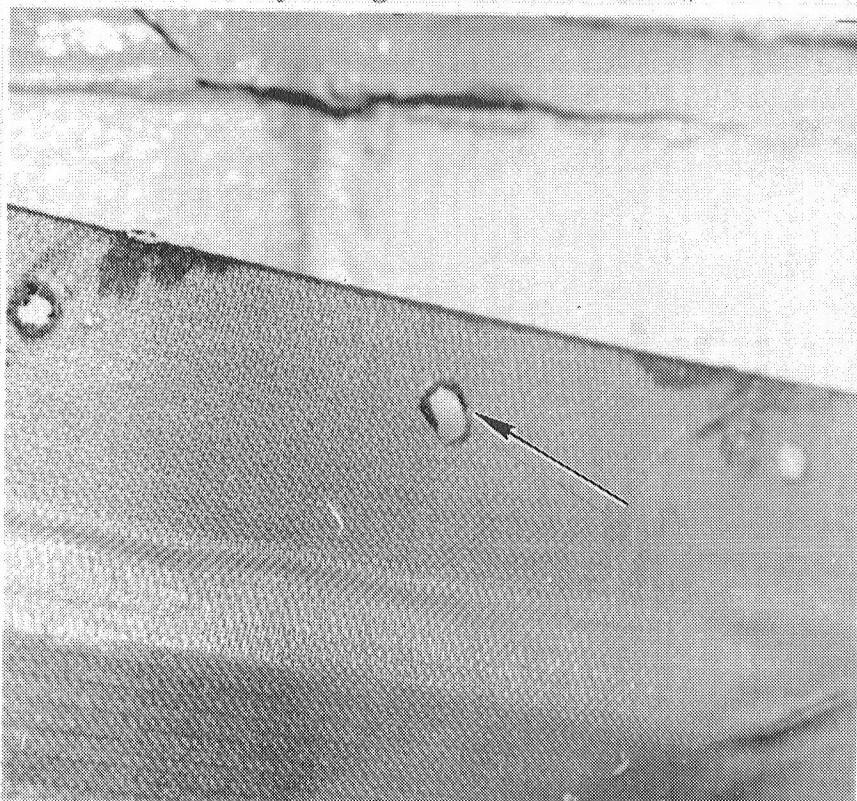
3. Slight fraying was observed on all fastener holes (figure 16), but the degree of fraying observed on this component is significantly less than any of the other Kevlar-49 aft engine fairings. The aft top edge had more fraying around the holes than the other edges.

4. Slight elongation was observed on several holes, with only one hole badly elongated along the lower edge (figure 16).
5. The intercostal holes (which go through the honeycomb) also had slight fraying. One intercostal hole was significantly elongated, while five others were slightly elongated (figure 17).

Figure 16. - Air Canada right-hand aft engine fairing - frayed holes with badly elongated hole.

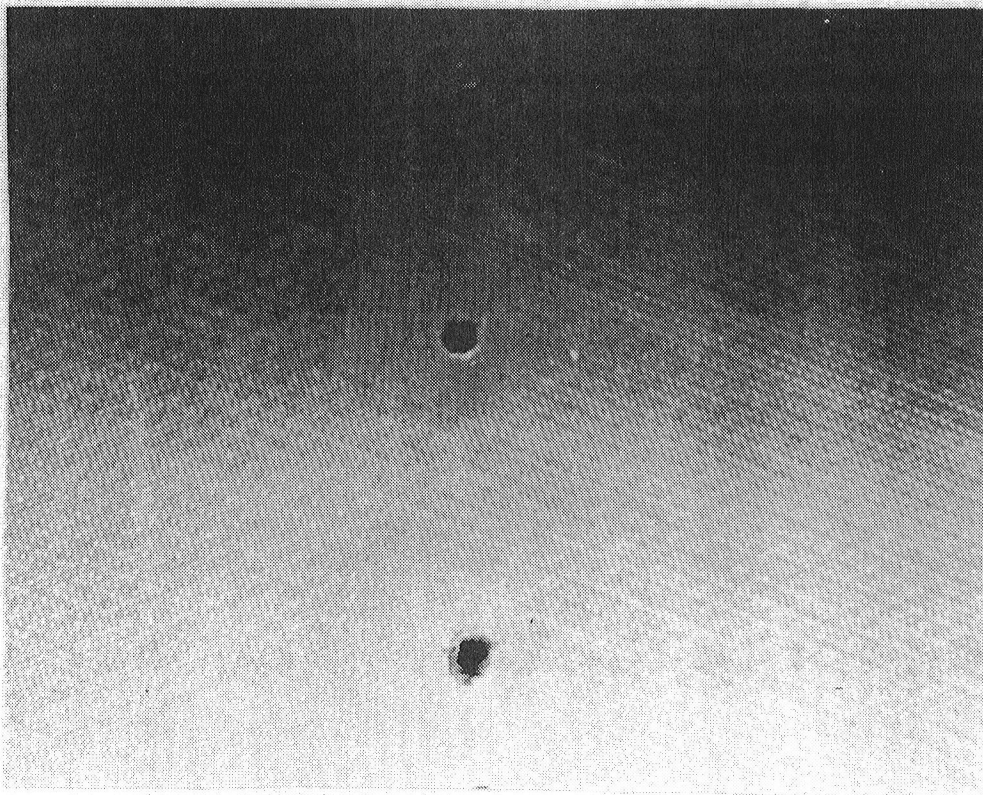
Figure 17. - Air Canada right-hand aft engine fairing - fraying of intercostal holes.

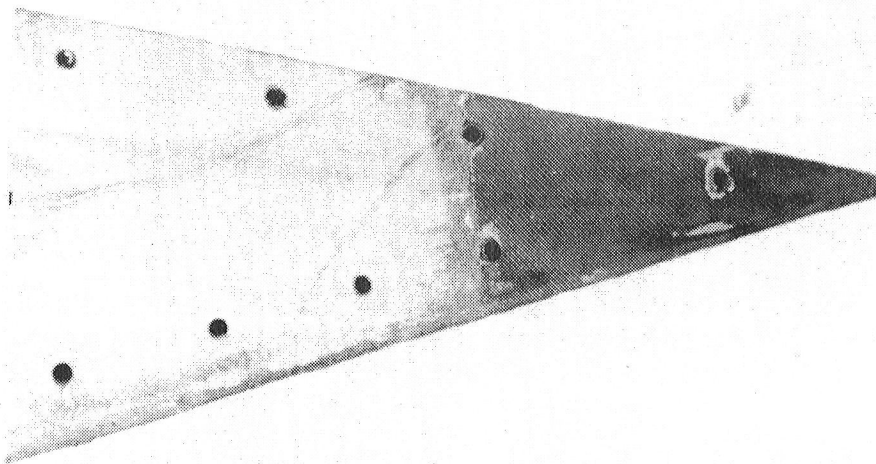
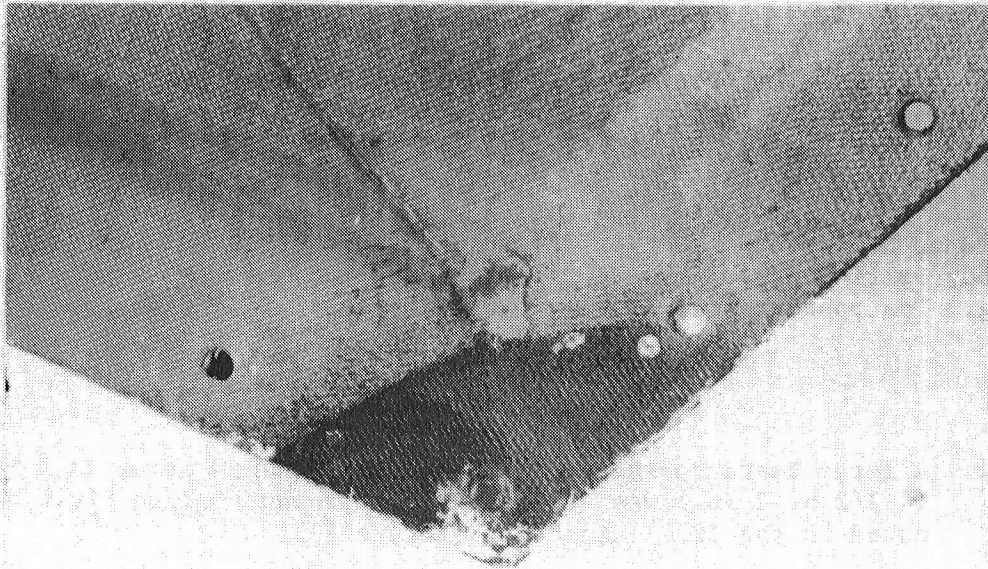
6. Two patch areas at the extreme forward and aft edges of the fairing were unchanged in appearance since originally observed in 1974 (figures 18 and 19). The patches are dark colored and fibrous, and may be some type of electrical tape overcoated with resin.

Figure 18. - Air Canada right-hand aft engine fairing - patch at forward edge.

Figure 19. - Air Canada right-hand aft engine fairing - patch at aft edge.

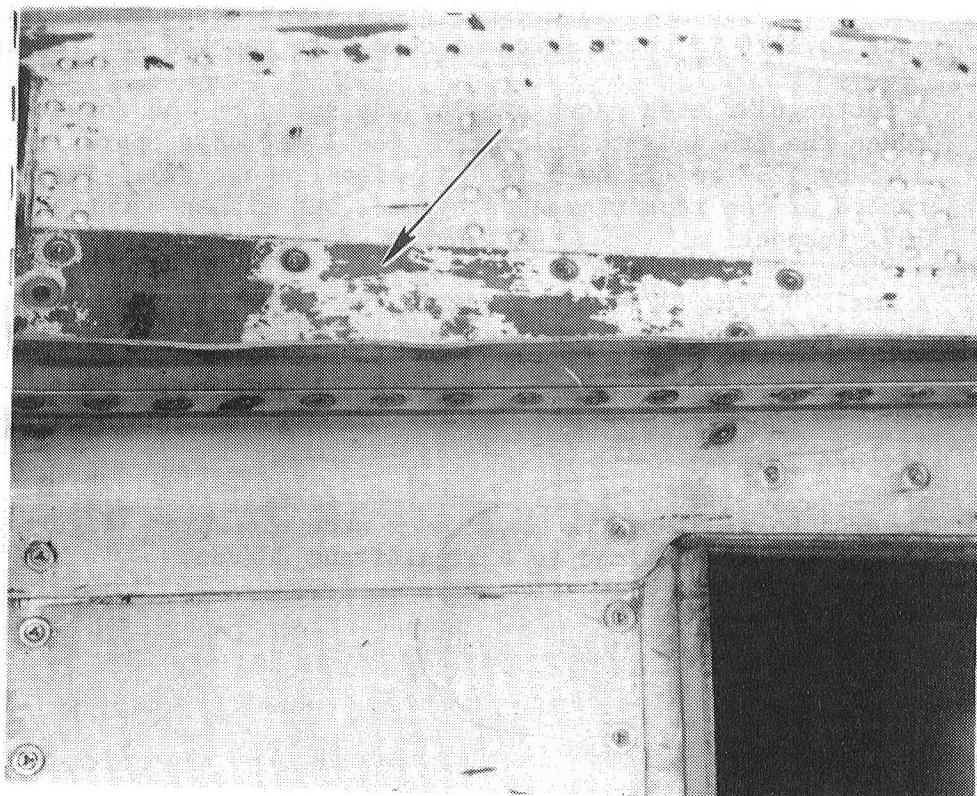
1. Considerable paint loss was observed with exposed Kevlar-49 surface in the upper area (figure 20), but with no damage to either surface. This area is not exposed to sunlight or ultraviolet.
2. A slight bulging of the lower aft edge was noted indicating a possible fit problem during installation. No fastener misalignment was observed, however.

Figure 20. - Air Canada right-hand underwing fillet on aircraft - showing paint loss in upper area.

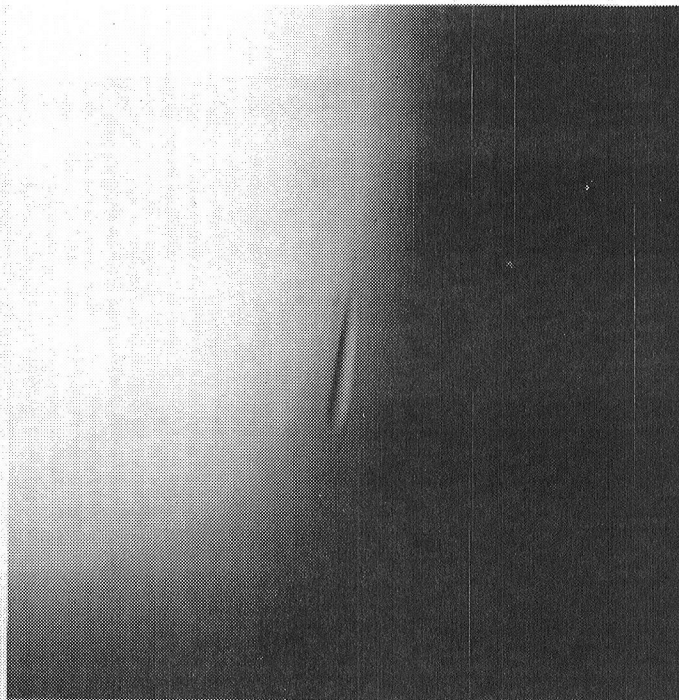
1. A large teardrop-shaped disbonded and crushed area, 11.4 by 2.5 cm (4 1/2 by 1 in.) was unchanged in appearance since first being noted in the 1977 inspection (figure 21).

3. Two slight depressions were noted, one in the upper forward and one in the upper aft area.
4. The above disbonds and crushed areas may be associated with repairs made in 1974 in which skin and core were removed and replaced.

Figure 21. - TWA right-hand wing-body fairing - crushed and disbonded area, exterior surface 11.4 by 2.5 cm (4.5 by 1 inch).

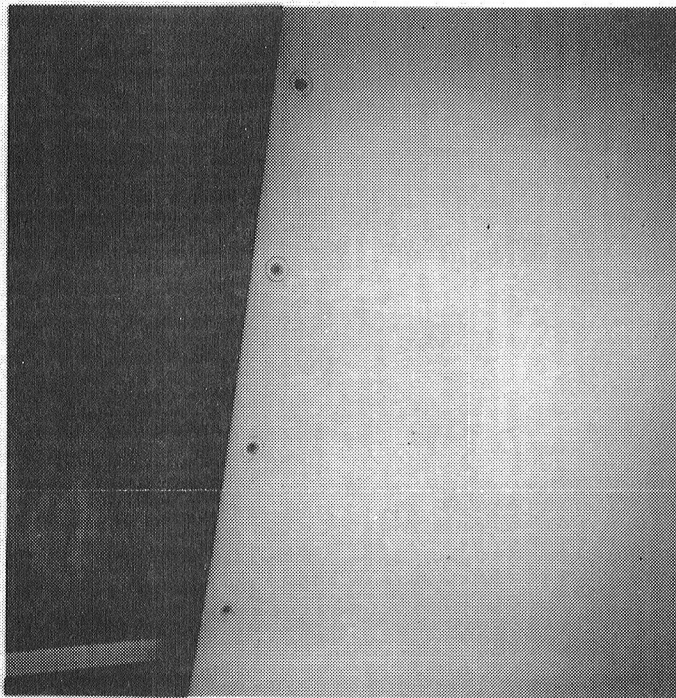
5. A rectangular area patch overlay was noted on the forward edge between the 6th and 7th holes from the lower edge approximately 30.5 by 12.7 cm (12 by 5 in.) in area (figure 22). There is no record of the repair procedure used, but it had occurred since the 1977 inspection.

Figure 22. - TWA right-hand wing-body fairing - rectangular patch area, 30.5 by 12.7 cm (12 by 5 inches).

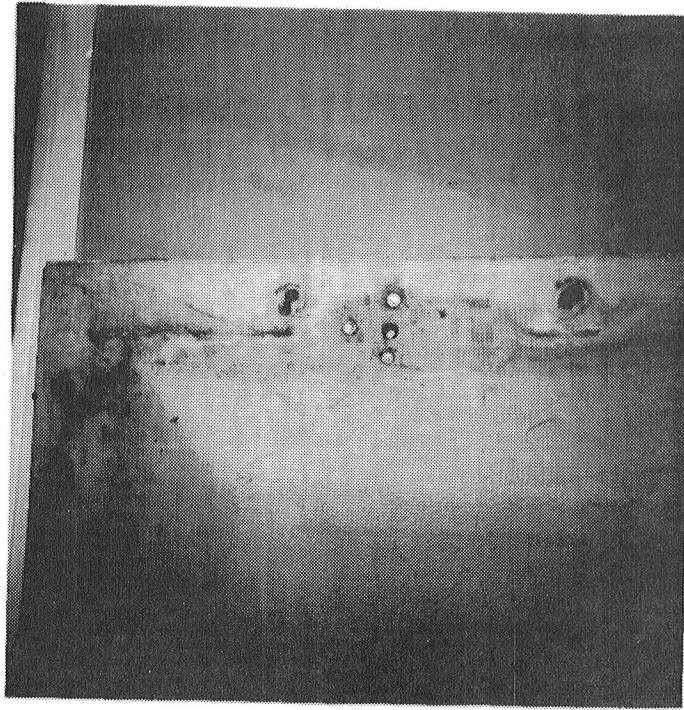
6. A small 0.3 cm (1/8 in.) crack in the lower aft area was unchanged in appearance or length since first observed in 1976.
7. Slight fraying was visible on the inner surface around all fastener holes and was more pronounced on the lower edge (figure 23).

9. The inner surface was deformed around some of the fastener holes (convex on the inner surface) as if partial fastener pull-through had occurred. This deformation was very slight along the top, forward, and aft edges; but was more pronounced along the lower edge.
10. A repaired hole at the lower aft edge was badly frayed and deformed. The original hole had been filled with chopped glass filled epoxy resin and redrilled (figure 23).

Figure 23. - TWA right-hand wing-body fairing - frayed and elongated holes, with repaired holes showing fraying and deformation.

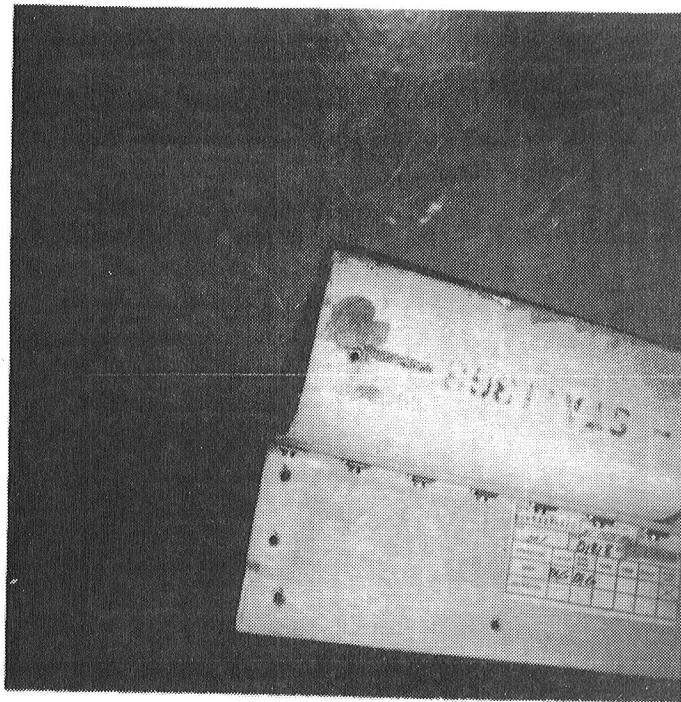
1. The panel was weighed using an accurate balance brought from Lockheed. The weight was 663.75 gms (1.463 lb).
2. No damage or defects were observed on either the exterior or inner surfaces.
3. Fraying was observed on all fastener holes and was more pronounced on the inner surface (figure 24). Five holes (out of 20) were frayed noticeably worse than the others.
4. About half the holes were deformed and elongated. Four holes were significantly deformed to a maximum 0.6 cm (1/4 in.) dimension from the original 0.5 cm (3/16 in.) hole size (figure 24). There was no correlation between the badly frayed and badly elongated holes.

Figure 24. - TWA right-hand underwing fillet - frayed
holes.

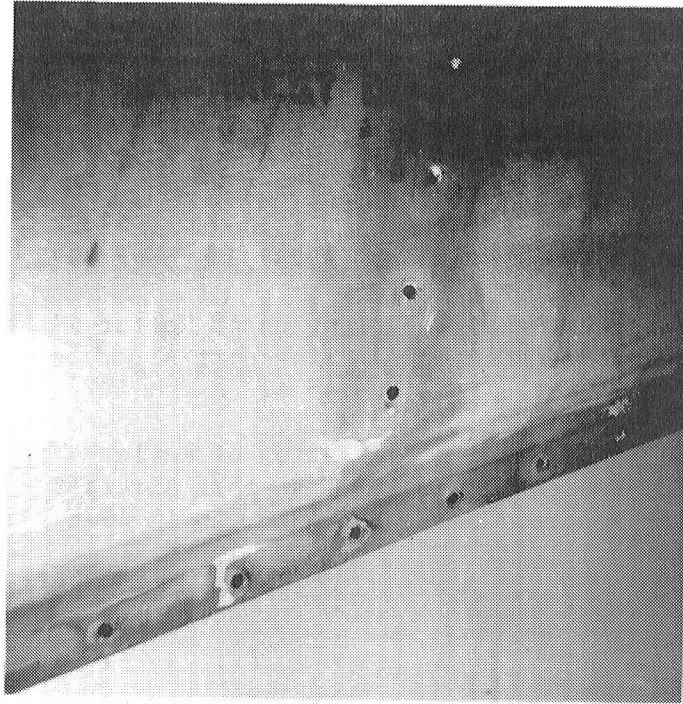
1. No damage was observed on either surface. Some paint cracking was noted in the aft area but there was no evidence of associated damage to the Kevlar-49 skins.
2. The fastener holes showed very little fraying (figure 25). This part had all fastener holes relocated upon re-installation into a second L-1011. A surface layer of 120 glass was applied to both surfaces before drilling apparently eliminating the fraying.
3. About one-third of the fastener holes (37 total) were deformed and elongated. Fourteen of these were significantly elongated to 0.6 cm (1/4 in.) or in two cases 0.8 cm (5/16 in.) maximum dimensions from the original 0.5 cm (3/16 in.) hole size. The holes with slight elongation included several intercostal holes which go through the honeycomb core.

Figure 25. - TWA left-hand aft engine fairing - showing
absence of fraying due to glass surface ply.
